**Draft Report
Project No. 60251**

**Volume 1 of 5
Remedial Investigation Report
ACS NPL Site
Griffith, Indiana**

**REMEDIAL INVESTIGATION REPORT
AMERICAN CHEMICAL SERVICES NPL SITE
GRIFFITH, INDIANA**

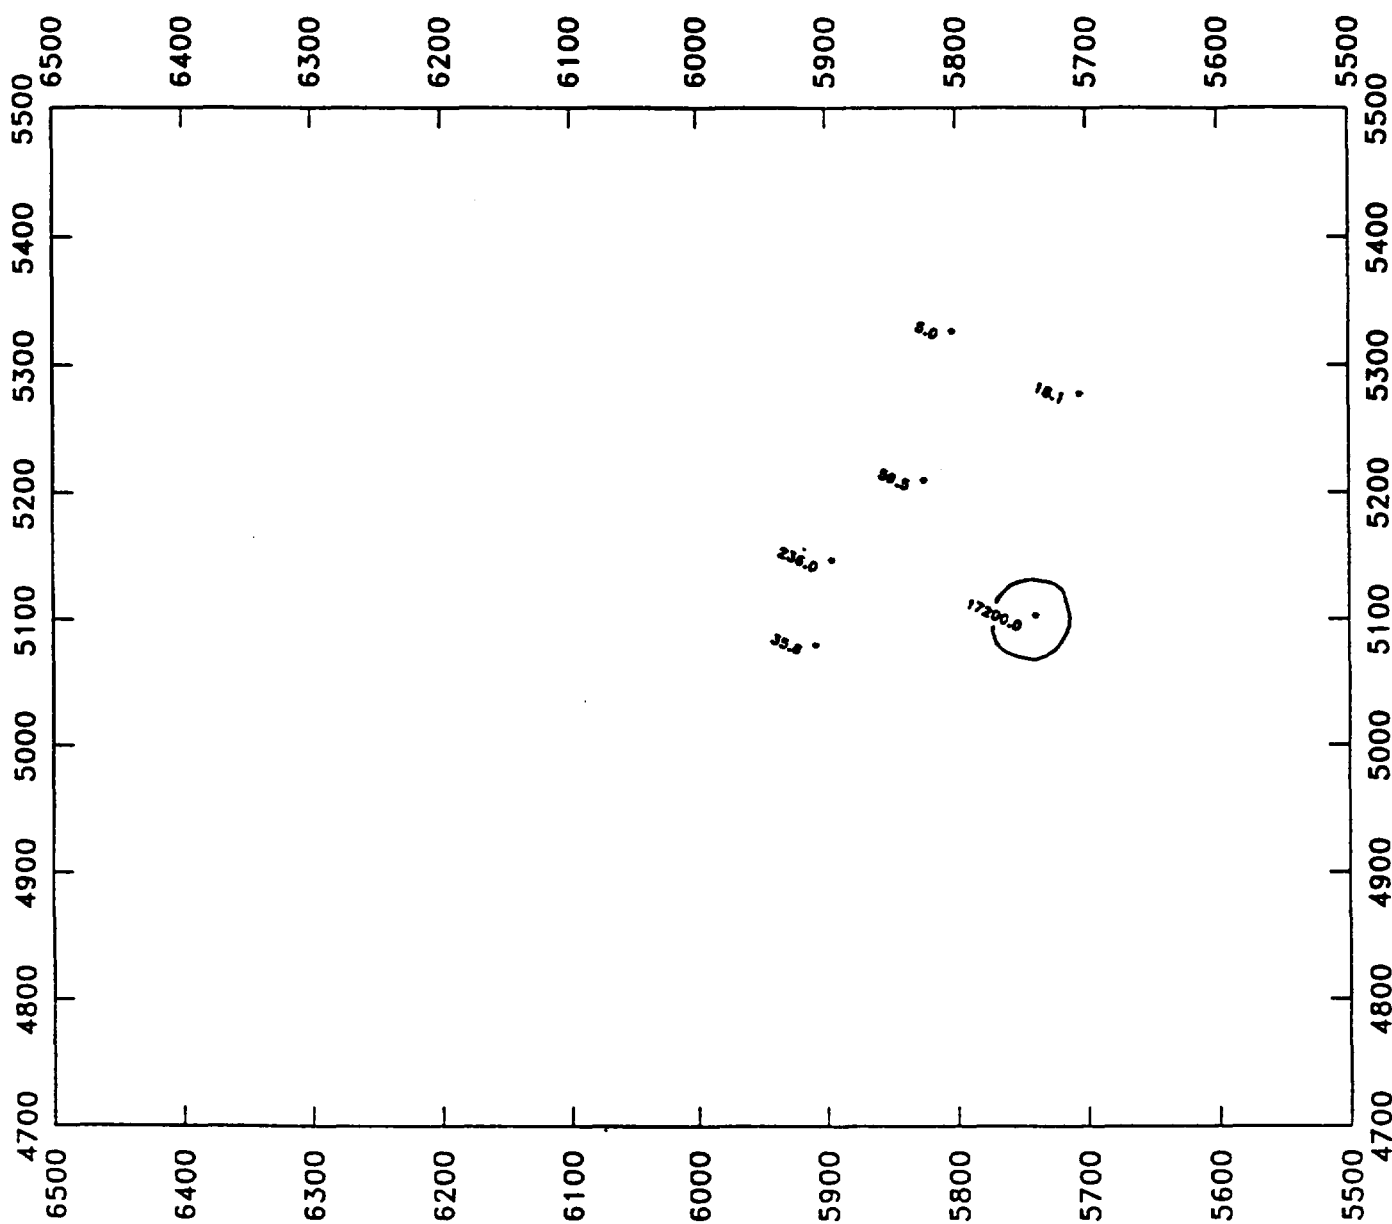
Figure 5-11c Approximate Extent of Lead Containing Wastes (> 500 ppm), Off-Site Areas (7-10 feet below surface). Posted Values are in ppm (mg/kg).

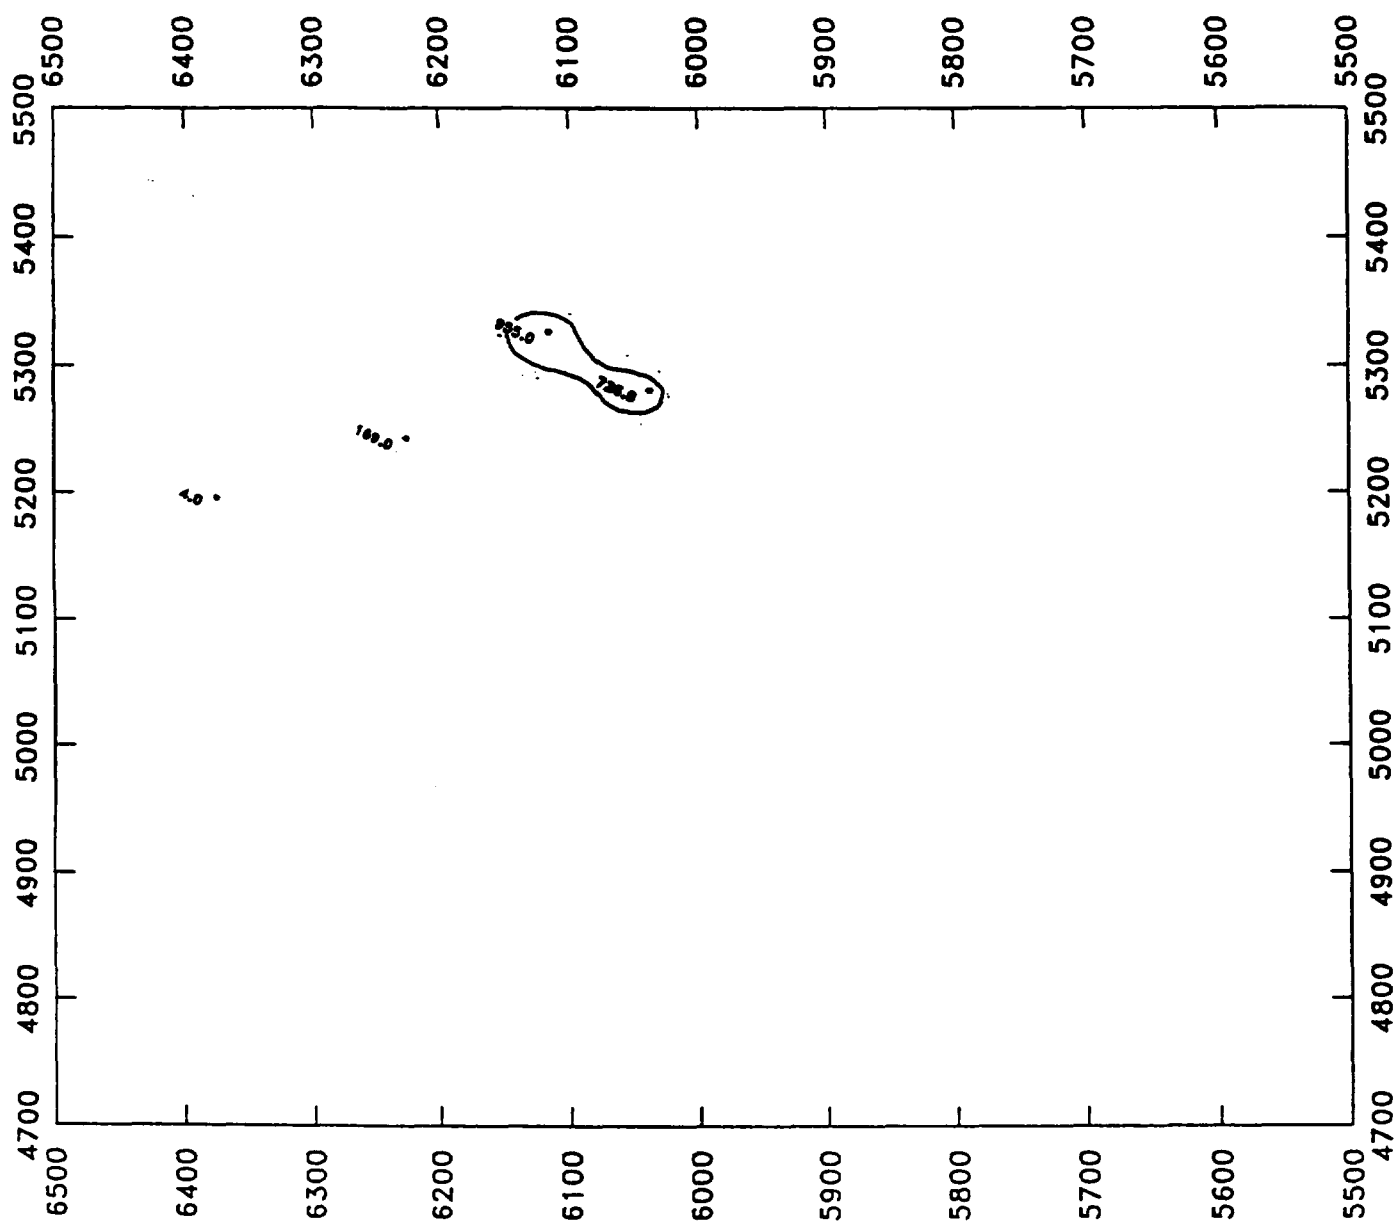
Figure 5-11d Approximate Extent of Lead Containing Wastes (> 500 ppm), Off-Site Areas (10-15 feet below surface). Posted Values are in ppm (mg/kg).

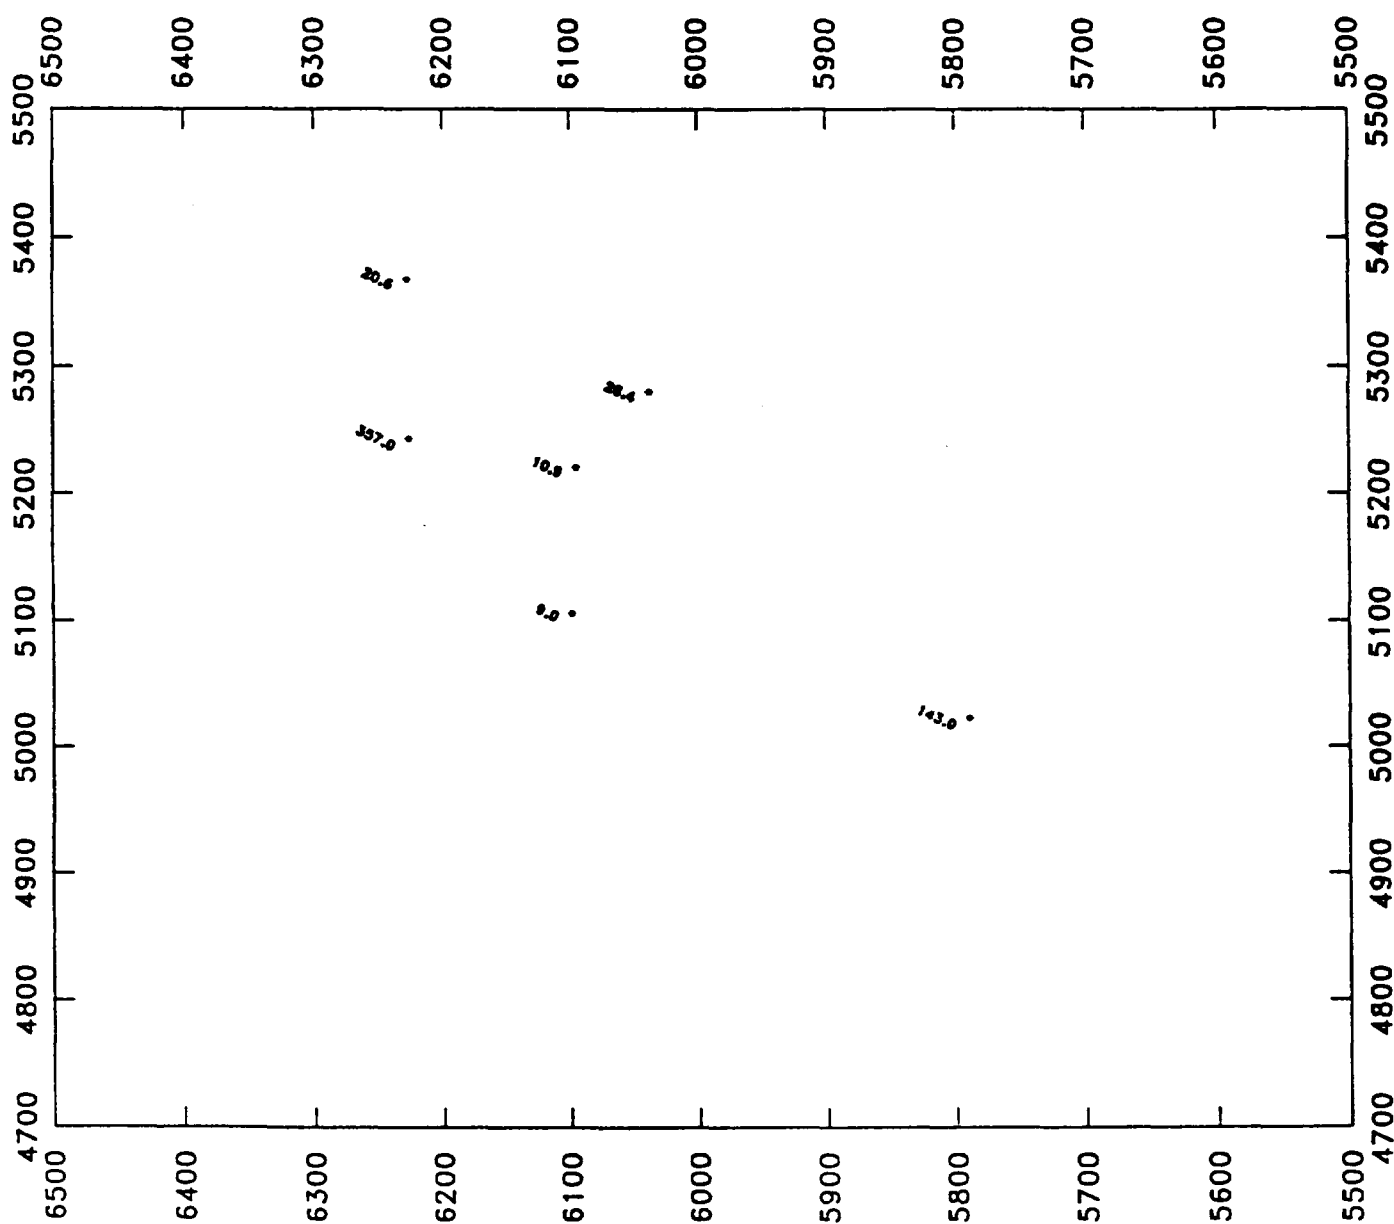
Figure 5-11e Approximate Extent of Lead Containing Wastes (> 500 ppm), Off-Site Areas (15-23 feet below surface). Posted Values are in ppm (mg/kg).
